Recent History of Glacial Lake Outburst Floods, Analysis of Channel Changes, and Development of a Two-Dimensional Flow and Sediment Transport Model of the Snow River near Seward, Alaska

Scientific Investigations Report 2022–5099

By Robin A. Beebee

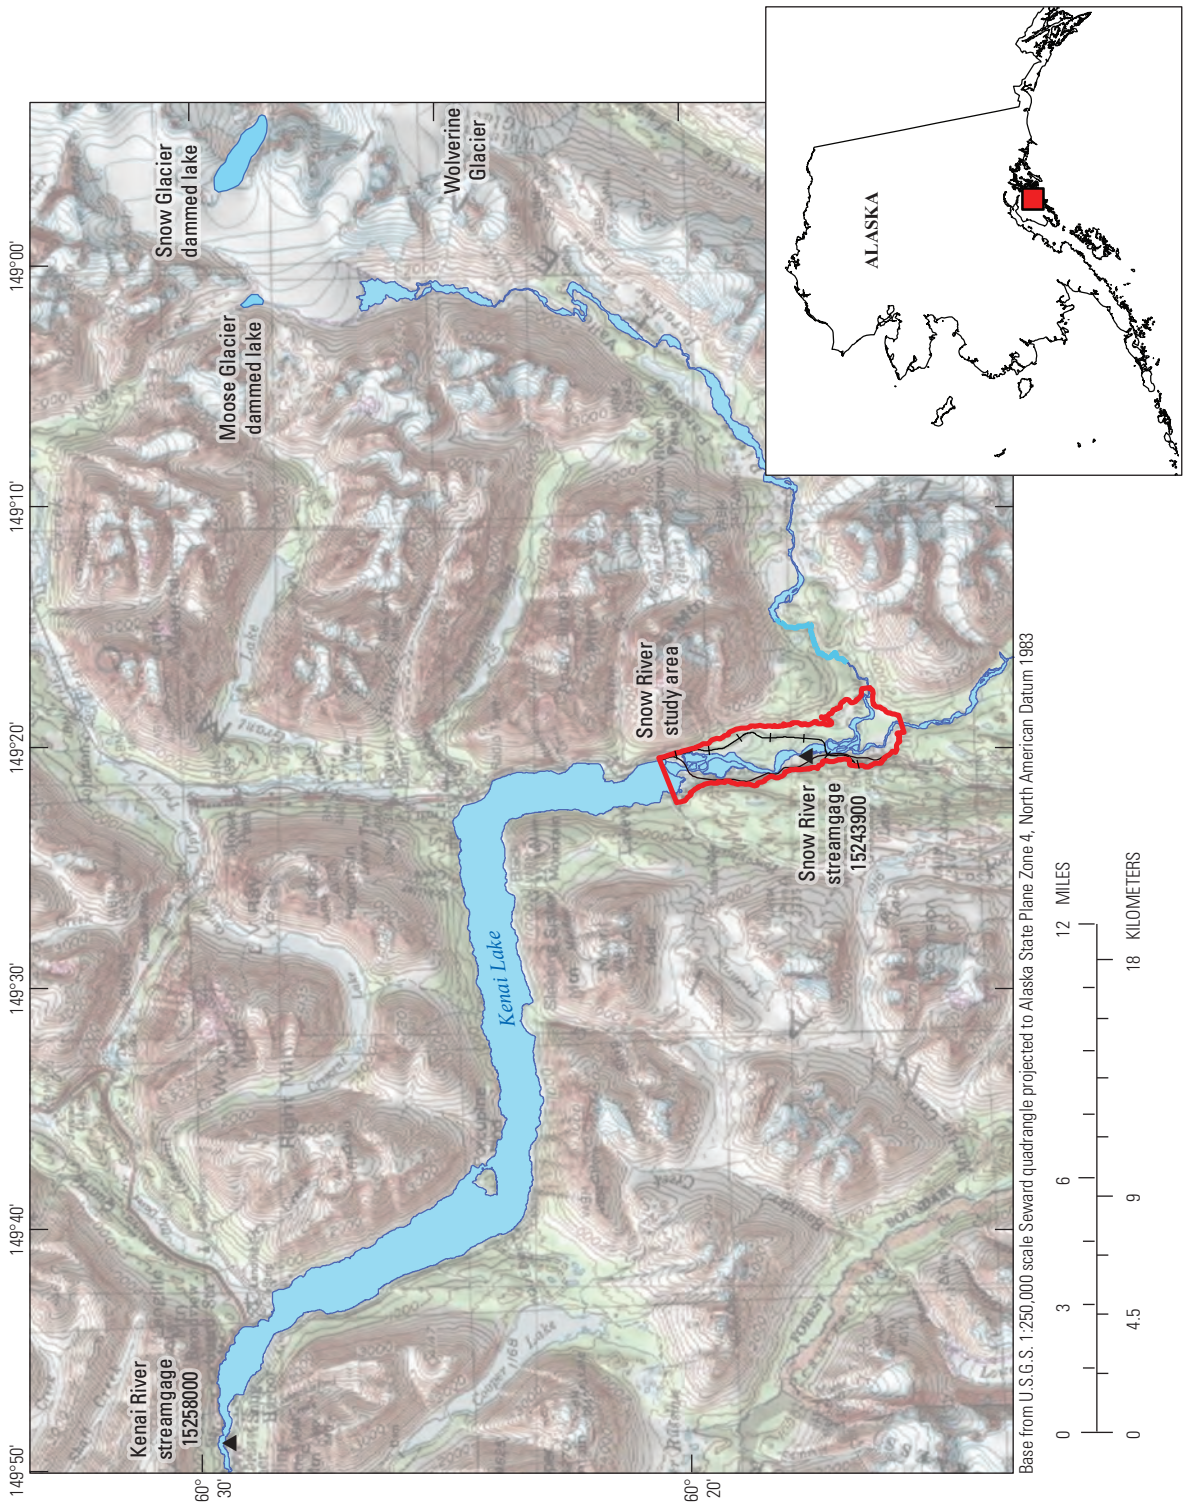
Figure 1. Snow River from Snow Glacier to Kenai Lake and relevant streamgages, near Seward, Alaska. Snow River study area outlines area of geomorphology and modeling analyses.

Two GDLs currently form along the Snow Glacier: Snow Lake at about 2,500 feet (ft) on the east side of the glacier and much smaller Moose Lake at the same elevation (but closer to the terminus) on the west side of the glacier (fig. 1). Moose Lake fills and drains several times each summer, but its contribution is too small to cause flooding on the Snow River. Snow Lake forms in a basin formerly occupied by the Snow Glacier. This basin does not have a significant catchment area for precipitation or snowmelt and fills primarily from glacial meltwater. Outburst floods from Snow Lake have been documented since 1949 (Chapman, 1981, NWS, 2019) and occur every 2–4 years. Lake levels at Snow Lake have been measured from the air using elevation markers first painted in 1969 (Chapman, 1981).

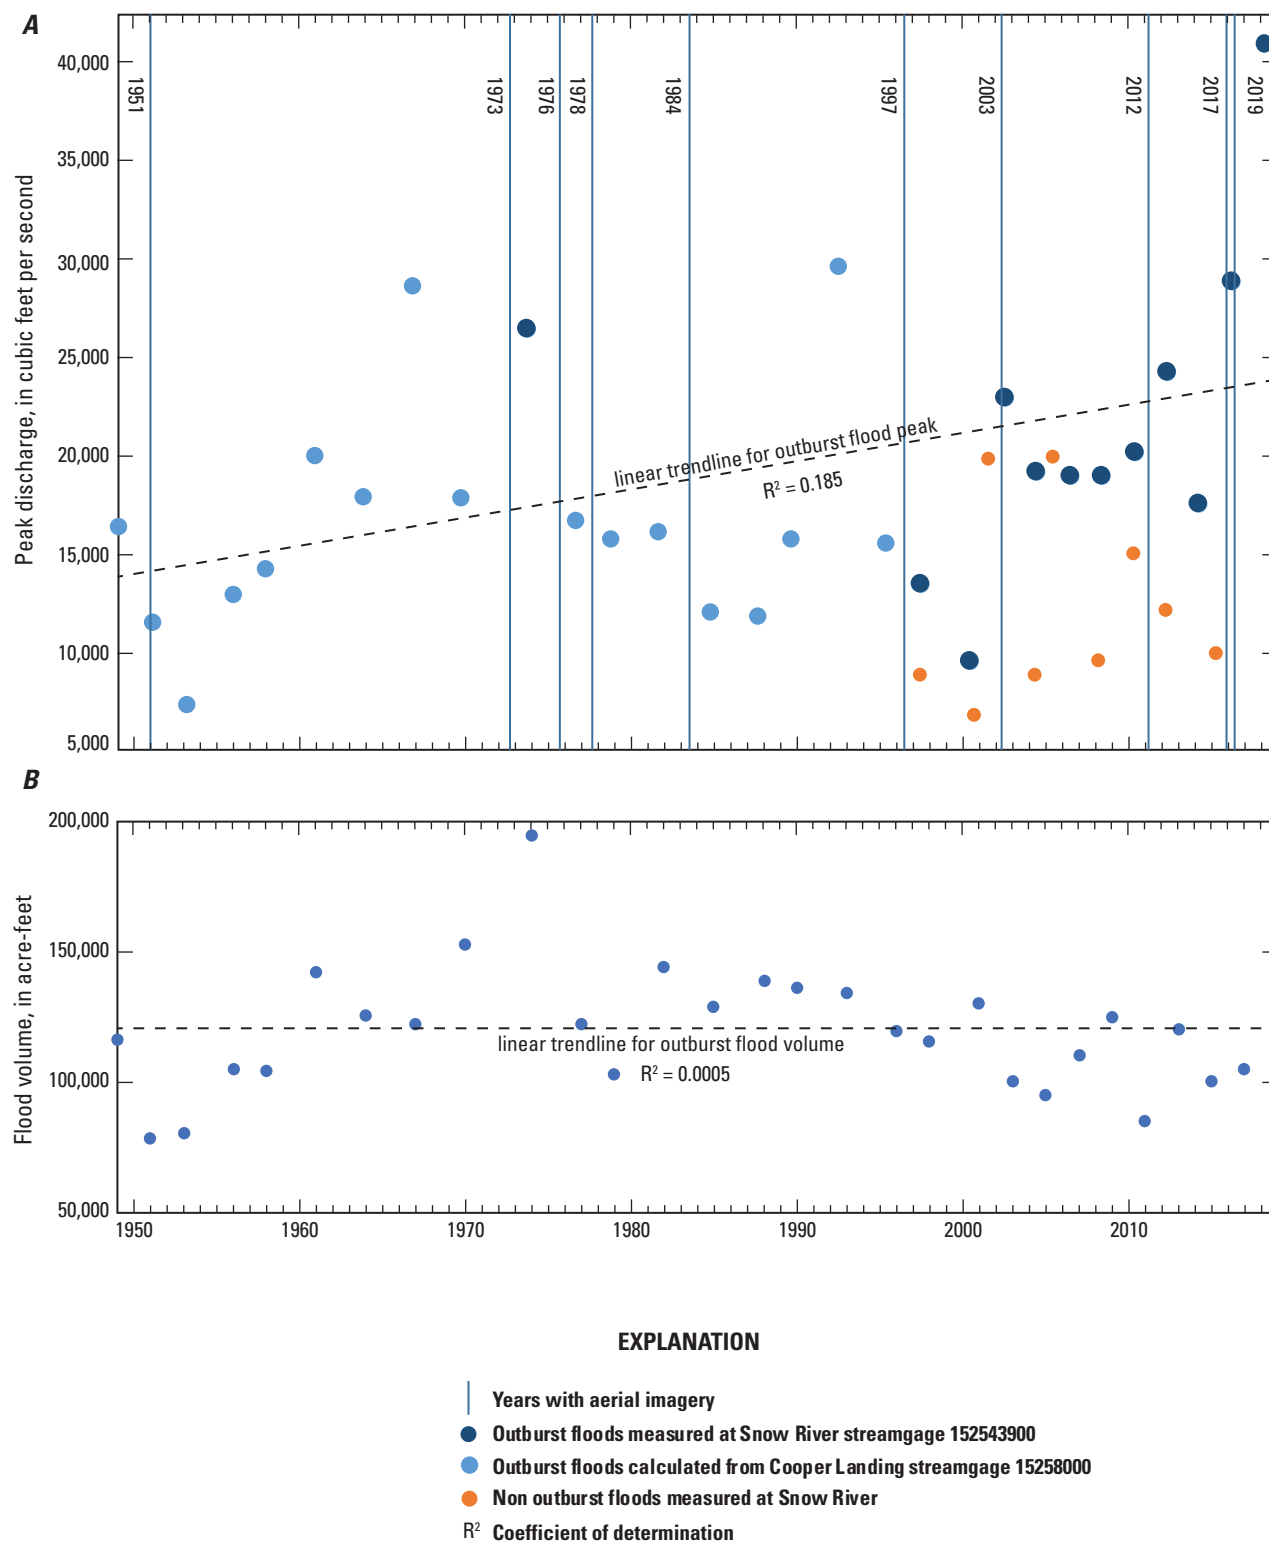
Figure 3. Peak discharges (A) and flood volumes (B) of the Snow River outburst flood since 1949, near Seward, Alaska. Estimated peaks and volume data from National Weather Service (2019).

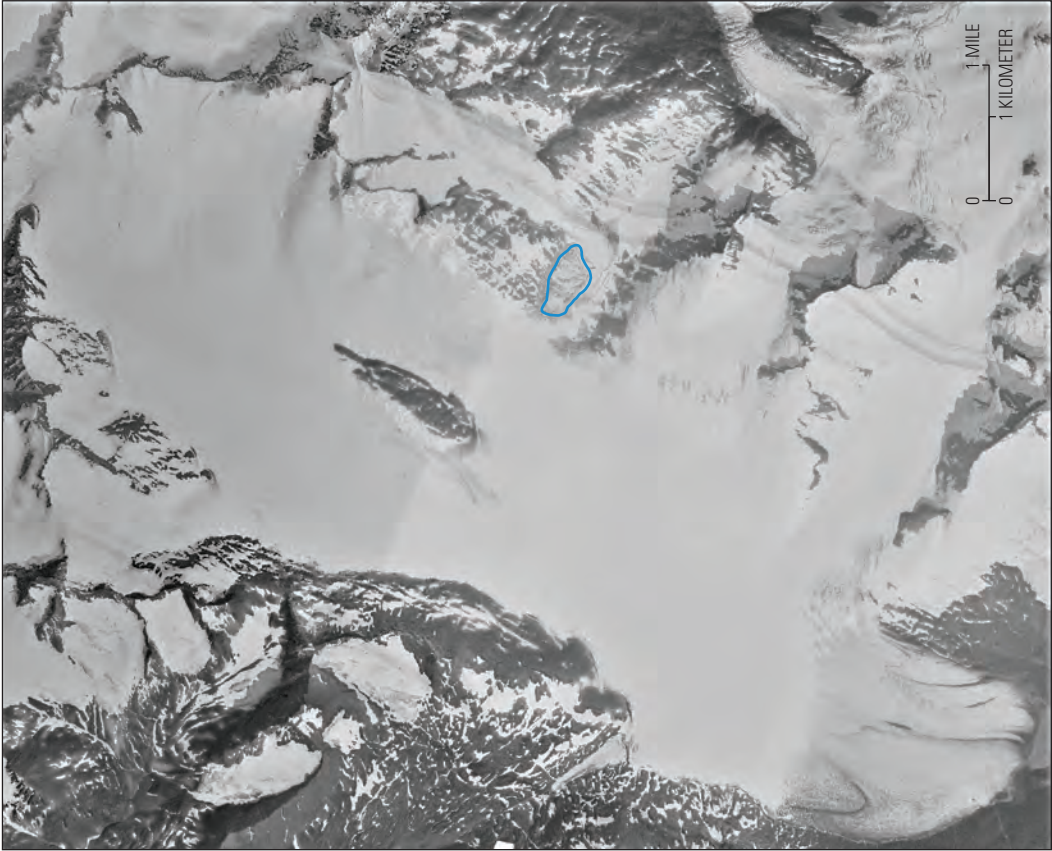
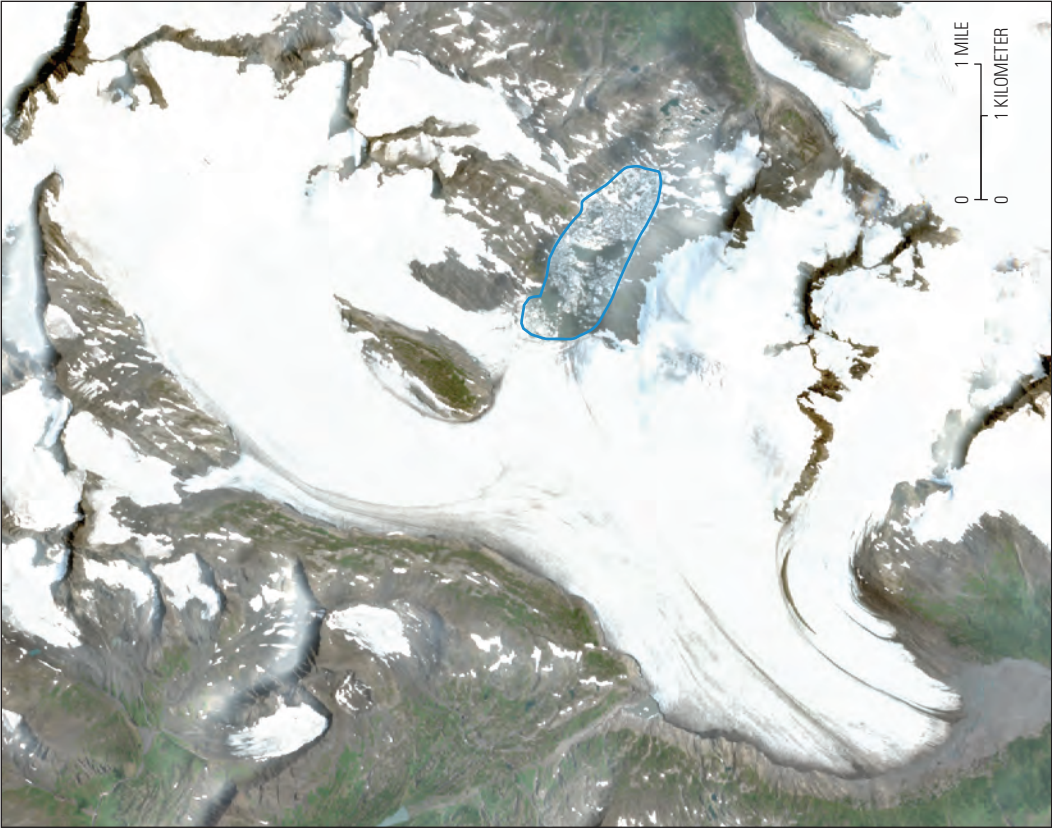
Figure 4. Comparison of Snow Glacier in (A) 1951 and (B) 2019, prior to floods in both years, near Seward, Alaska. Visible water in lake outlined in blue.

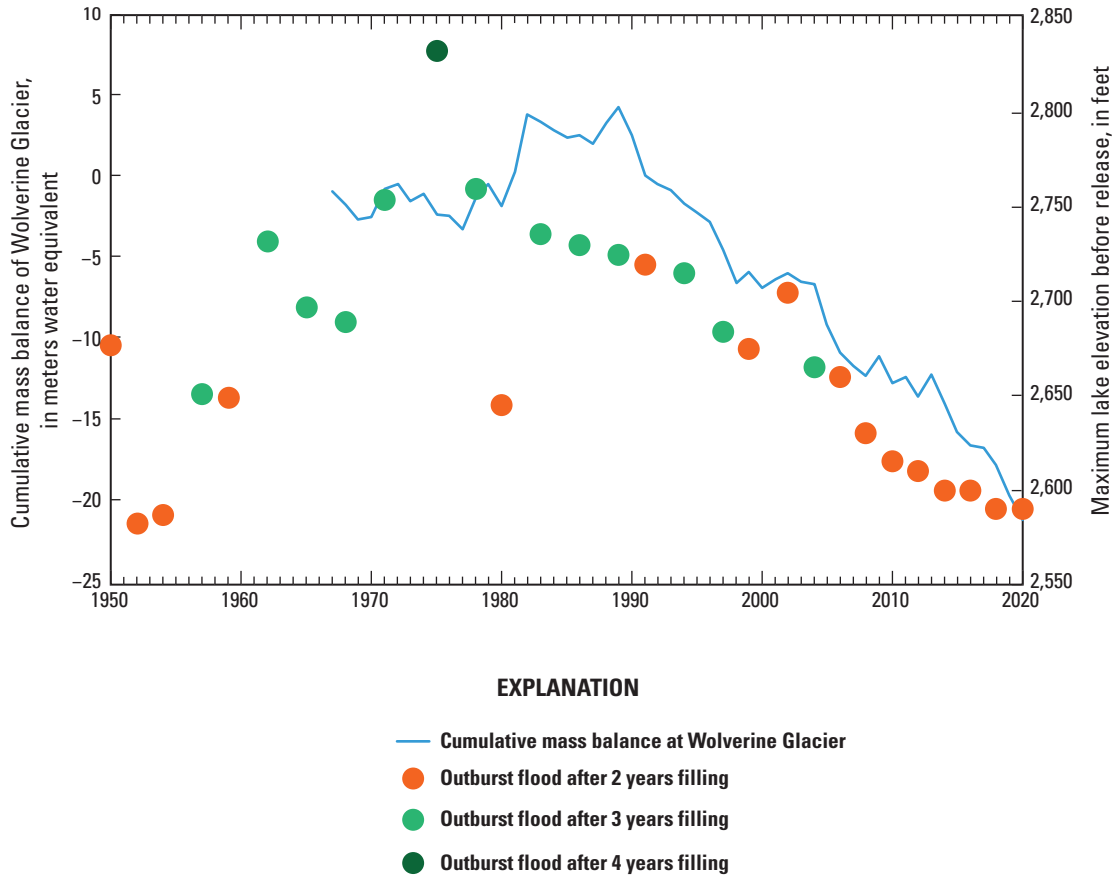
Figure 5. Approximate peak Snow Lake elevation before release and cumulative mass balance of Wolverine Glacier since 1949, near Seward, Alaska. Data from the National Weather Service (2019).

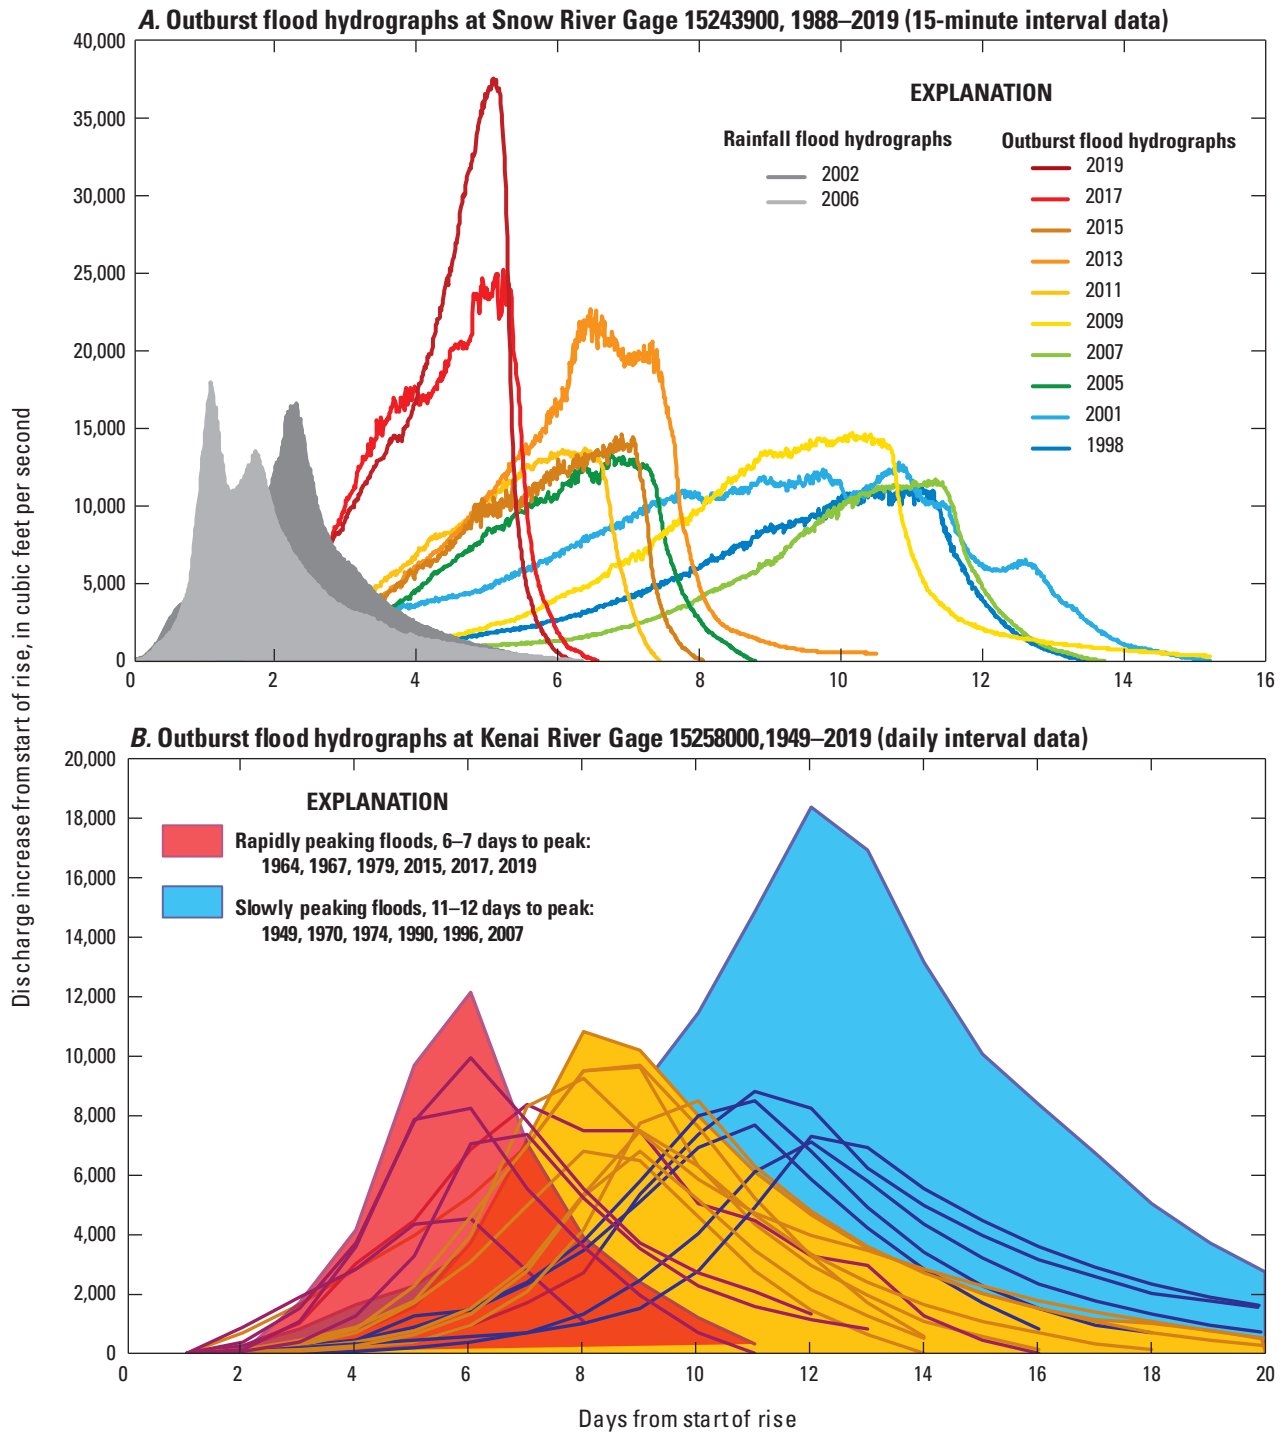
Figure 6. Comparison of Snow Glacier outburst flood hydrographs from 1998 to 2019 and rainfall floods from 2002 and 2006 at Snow River streamgauge (A) and comparison of daily hydrographs during Snow Glacier outburst floods from 1949 to 2019 at Kenai River streamgauge downstream of Kenai Lake (B), near Seward, Alaska (U.S. Geological Survey, 2022).

2002 and 2006. The peak and duration of GLOFs depends on the lake volume and the thermal development of subglacial drainage paths beneath the Snow Glacier. Concurrent precipitation sometimes increases flow during these events. There is evidence that the glacier and lake system have changed over time. Comparison between a 1951 aerial photograph of the area surrounding the lake and a more recent image acquired in 2019 (fig. 4) shows significant glacial ice loss around the lake, and measurements on adjacent Wolverine Glacier (fig. 2) show recent rapid thinning (O’Neel and others, 2014; Baker and others, 2018). While an investigation of the subglacial drainage process is beyond the scope of this study, some general trends in the character of the outburst flood can be partially explained by glacial thinning. The most apparent trend is toward lower water-surface elevation lake releases since 1982 (fig. 5). This is consistent with a similar long-term record of annual outburst floods at Hidden Lake Creek in the Wrangell Mountains, which has released at lower and lower lake elevations over the last 90 years as the glacial dam thinned (Rickman and Rosenkrans, 1997). Floods also appear to be becoming more frequent. All floods between 2001 and 2019 have occurred after 2 years of filling, and the most recent flood in 2020 occurred after just 14 months of filling. Between 1949 and 2001, 12 floods occurred after 3 years and 6 occurred after 2 years. One exceptionally high-volume flood in 1974 occurred 4 years after the previous flood (fig. 5). There is a weak trend over time toward larger (higher peak) outburst floods but no apparent trend in flood volume (fig. 3). Finally, since the Snow River streamgage near Seward was established in 1998, there is a trend toward floods peaking faster (shorter time from start of rise to peak flow). The especially rapid peaks in 2017 and 2019 accentuate this trend (fig. 6). Records from the downstream streamgage 15258000 on Kenai River at Cooper landing show that the Snow Glacier outburst floods in 1964, 1967, and 1979 appear to have peaked as rapidly as floods from 2017 and 2019, while the remainder of the floods peaked more slowly (fig. 6).

Snow Lake outburst flood hydrographs differ from meteorological hydrographs in duration, volume, and peak discharge magnitude. Water draining from the lake flows over 4 miles through subglacial conduits to reach the river. Discharge increases as the conduits are enlarged by the flowing water. Thus, the conduits are largest and discharge is highest when the lake is nearly empty. After the peak, discharge from the lake drops precipitously. Rainfall floods have rapid increases and short duration peaks, even compared to the flashier 2017 and 2019 outburst events (fig. 6).

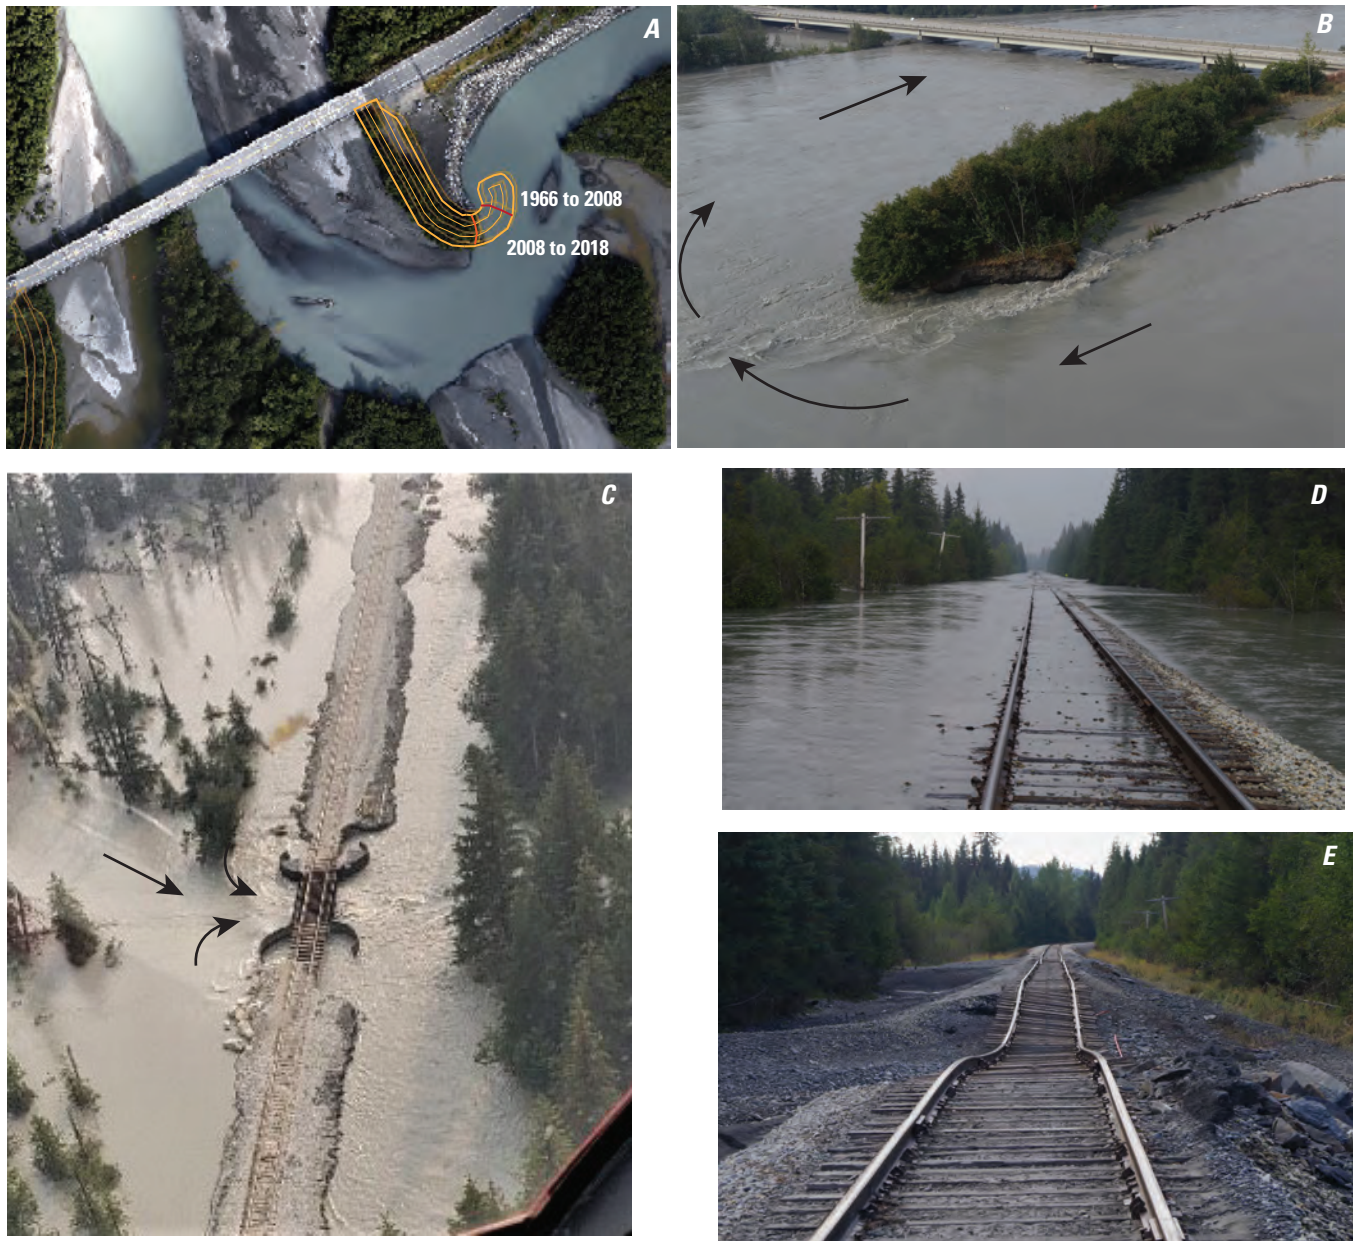
Figure 7. Damage from outburst floods on the Snow River near Seward, Alaska. (A) As-built dimensions of eastern guidebank at Bridge 605 overlaid on 2018 aerial photography (Kinzel and Legleiter, 2021). 2008 and 2018 extents of guidebank delineated. (B) Uncrewed Aircraft System photograph of eastern guidebank during the August, 2019 flood. Photograph taken by Kirsten Valentine, Alaska Department of Transportation and Public Facilities. Arrows follow flow path. (C) Bridge 16.2 during peak of 2019 flood showing loss of fill from sheet pile cells. Photograph taken by Blake Aldolfae, Alaska Railroad Corporation. (D) Train tracks as seen looking east near milepost 15 along railroad grade near the 2019 flood peak. (E) Train tracks as seen looking west near milepost 15 after the peak of the 2019 flood. (D) and (E) are U.S. Geological Survey photos taken August 24, 2019, and August 26, 2019, respectively.

The eastern guidebank at Bridge 605 is necessary to align the flow with the bridge opening. The guidebank toe has been undercut repeatedly by scour during outburst floods, resulting in loss of 85 ft of length since construction in 1966, about 50 ft of which occurred after 2008, based on the 2008 lidar dataset (Kenai Watershed Forum, 2008) (fig. 7). Flow parallel to the highway has overtopped a riprap revetment and scoured the highway embankment.

The railroad grade between MPs 14.5 and 18 is located mostly on a low-elevation floodplain. At higher flows, floodwaters leave the main channel and cross the grade through drainage structures at MPs 15.2 and 15.6 or bypass Bridge 14.5 and enter the floodplain to the east of the grade. An alluvial fan prevents flow from traveling along the grade past MP 16.7, and here the grade acts like a dam, preventing flow that has become trapped east of the grade from returning to the main channel (fig. 7). In 2017 and 2019, enough water was trapped to overtop and erode the grade between MPs 16.4 and 16.7. The 28-ft long bridge at MP 16.2 suffered over 14 ft of scour and lost fill from sheet-pile abutments during the 2019 flood. The rail grade has also been overtopped at low areas near MPs 15 and 17 and suffered loss of ballast from below the tracks (fig. 7).

Simulating flood inundation and flood damage potential along the railroad grade was one of the primary goals of the SRH-2D modeling. The 2019 flood model simulated approximately 14 ft of scour at Bridge 16.2, as well as up to 6 ft of fill loss where the grade was overtopped at MP 16.4 (fig. 22) and up to 2 ft of fill loss at MP 15. Fill loss was not documented post-flood at MP 16.4. Photographs at MP 15 suggest up to 3 ft of fill loss (fig. 7).

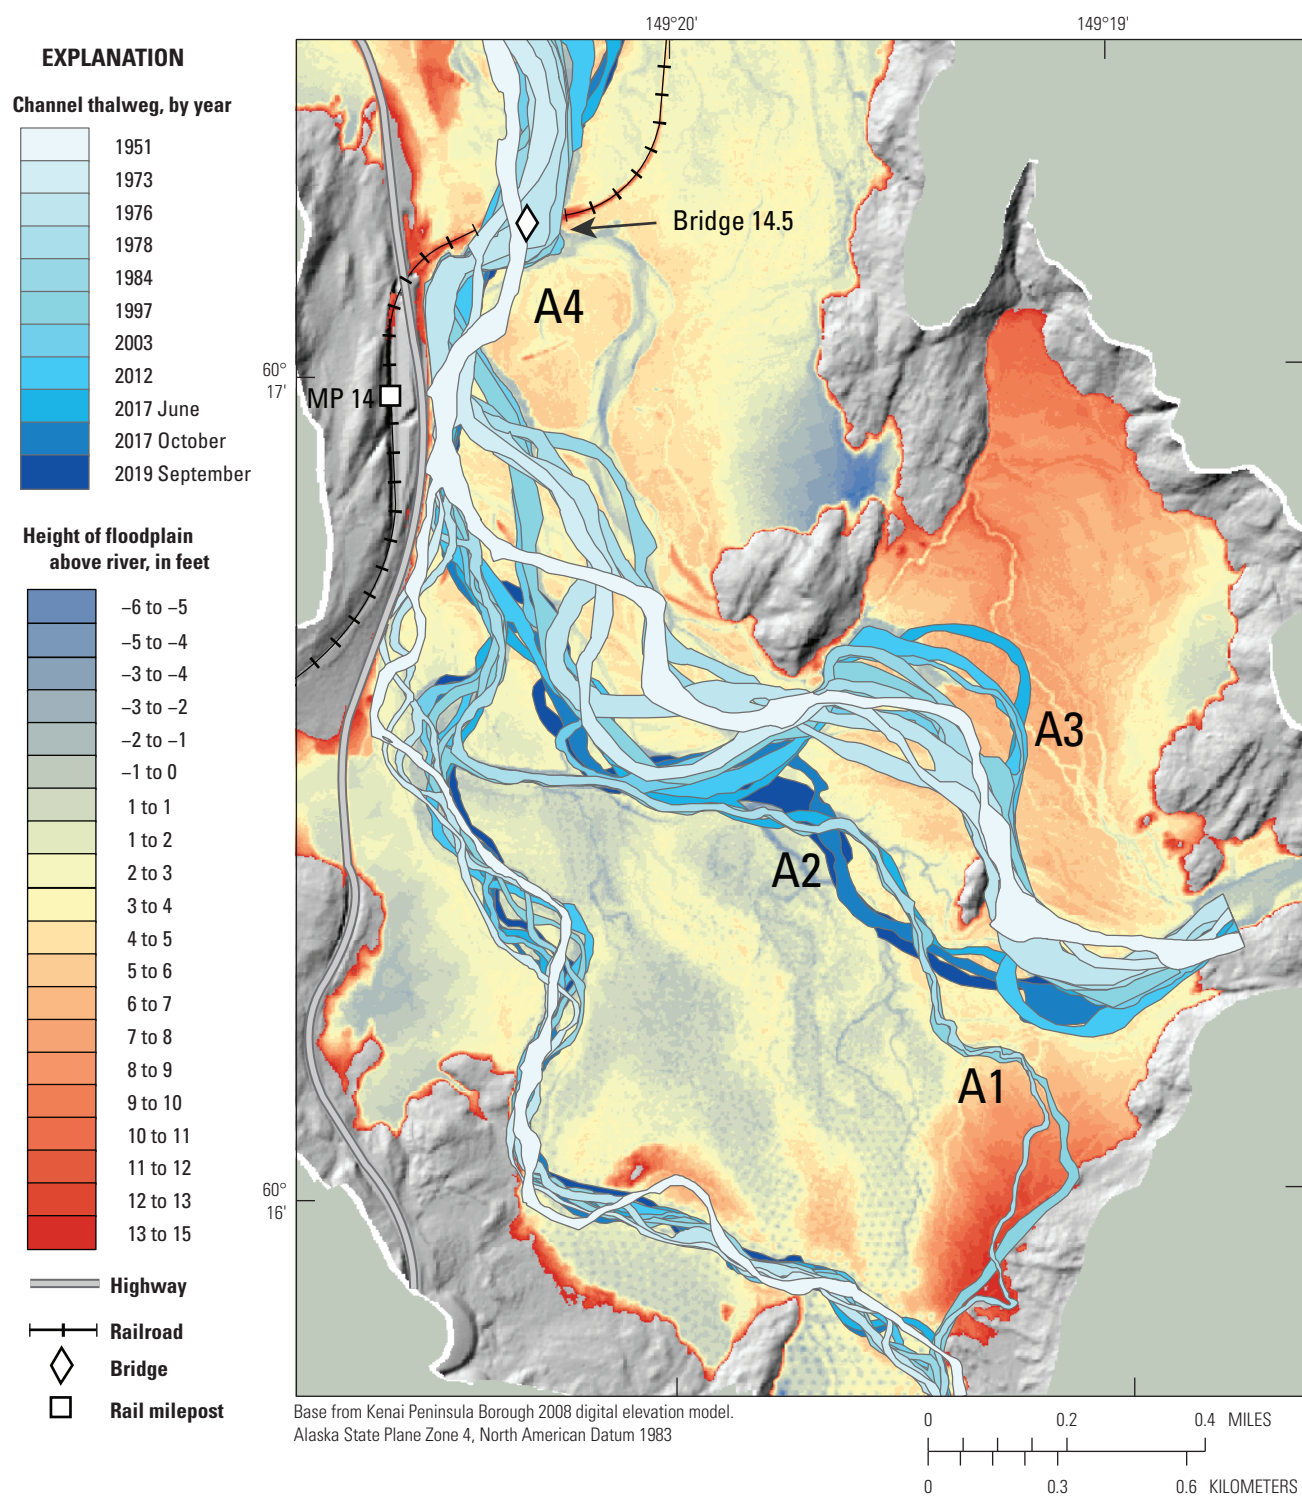
Figure 9. Analysis of reach A with historical channel locations overlaid on a Height Above River raster, near Seward, Alaska.

The confluence of the South Fork of the Snow River with the main fork of the Snow River is a broad alluvial plain broken up by bedrock knobs. As measured from the 2008 lidar, the main channel slope is about 0.3 percent. The channel change in reach A is important because it recruits and transports woody debris to Bridge 14.5 and determines the approach angle of flow to the bridge (fig. 9). The main channel also flows against Seward Highway embankment in this reach. The smaller South Fork of the Snow River channel has remained relatively stable in an active braid plain compared to the larger Snow River channel. However, in the 1978 and 1997 imagery, the main flow detoured north through a channeled wetland (A1) and rejoined the prevalent channel over a mile downstream (fig. 9). From 1951 to 2012, the main Snow River meander bend at A3 migrated eastward. In June 2017, the main channel of the Snow River was split, with some of the flow occupying the wetland and forested side channels at A2. After the 2017 flood, the meander bend at A3 was completely cut off and the main channel flowed through A2. The new channel contributed most of the mature trees found on the floodplain and against the rail bridge downstream. The flood in 2019 widened the channel at A2. The main channel has been on the west side of the island at A4 in every image reviewed, although it has approached the island from different locations. Erosion of the island at A4 could make flow through the rail bridge more orthogonal. If the side channel east of the island captures the main flow, it would increase the risk of flooding around the rail embankment. The HAR raster shows generally lower elevations in the area between the South Fork of the Snow River and the main channel of the Snow River. These low-lying areas are more likely to be inundated during floods now that the main channel has abandoned the meander bend to the north (A3).

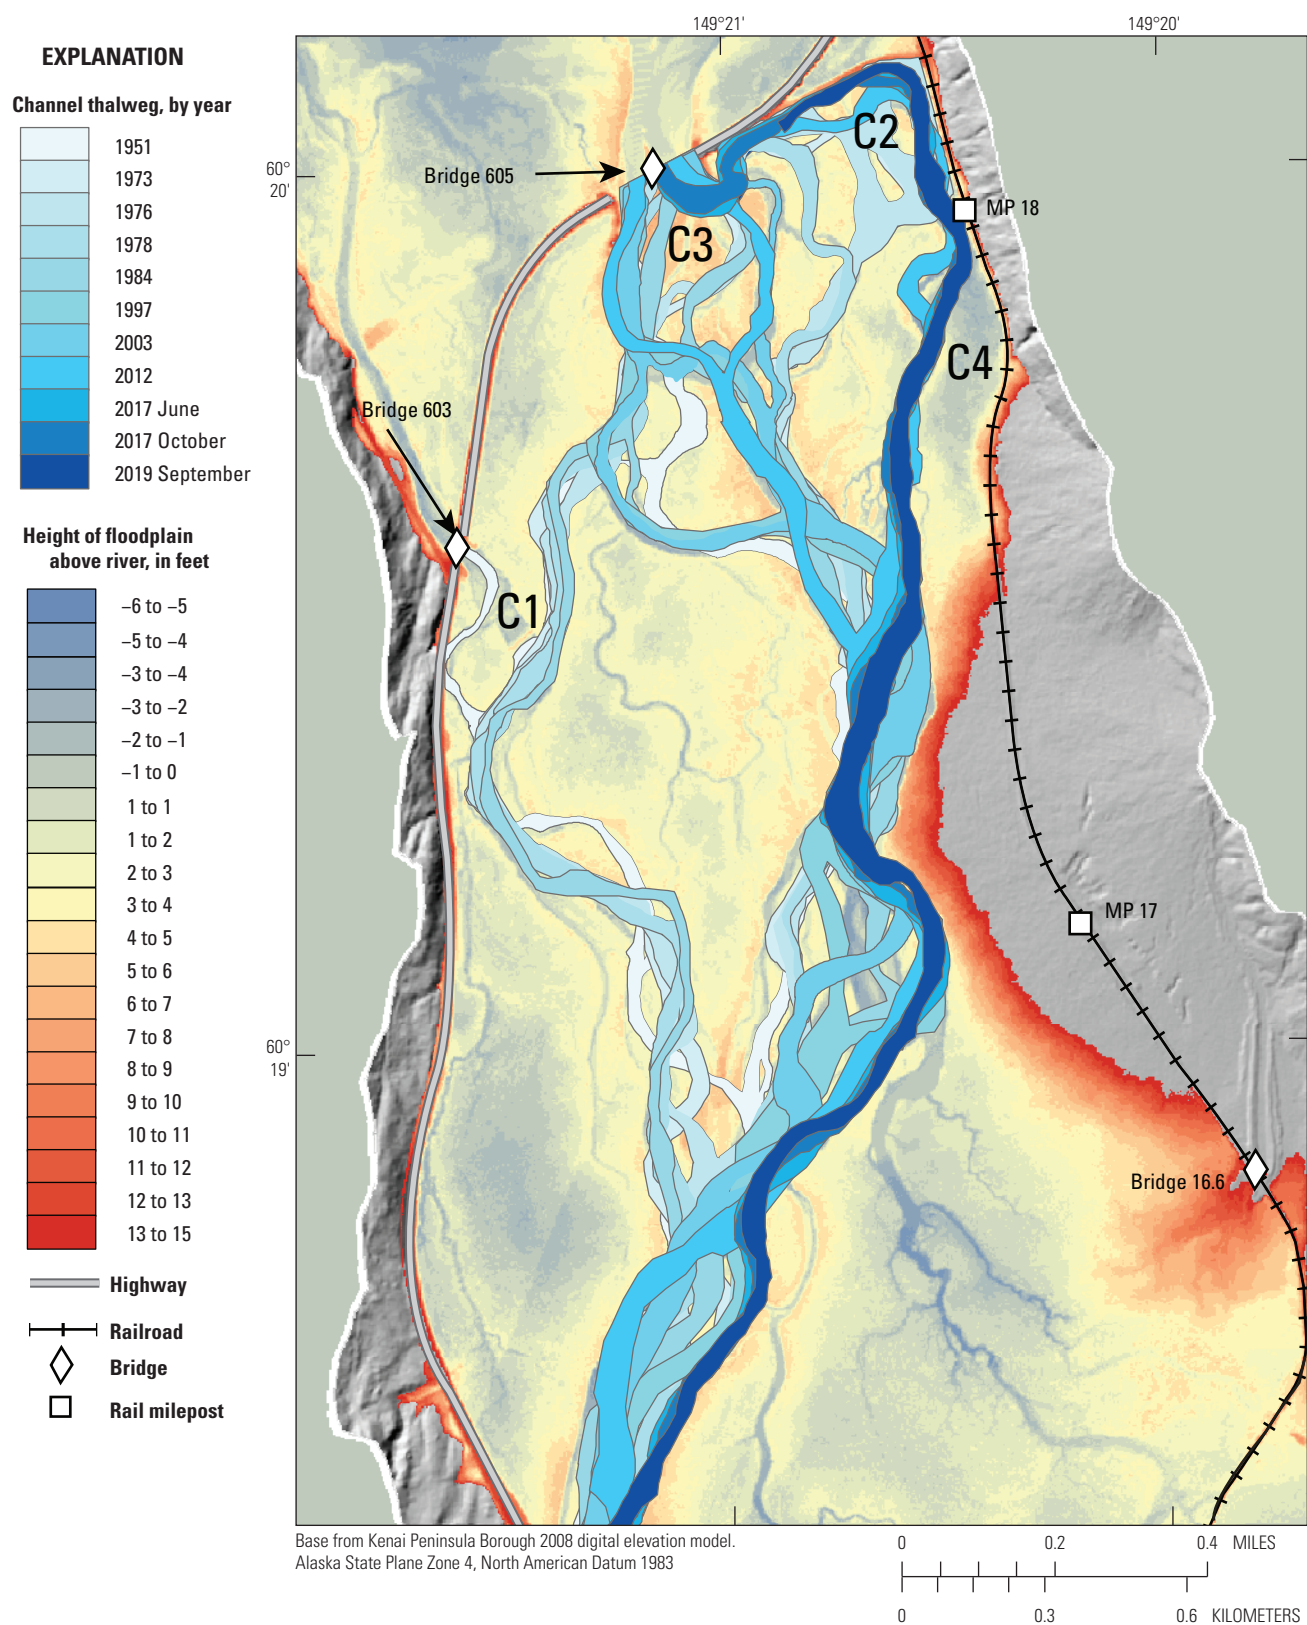
Figure 11. Analysis of reach C with historical channel locations overlaid on a Height Above River raster, near Seward, Alaska.

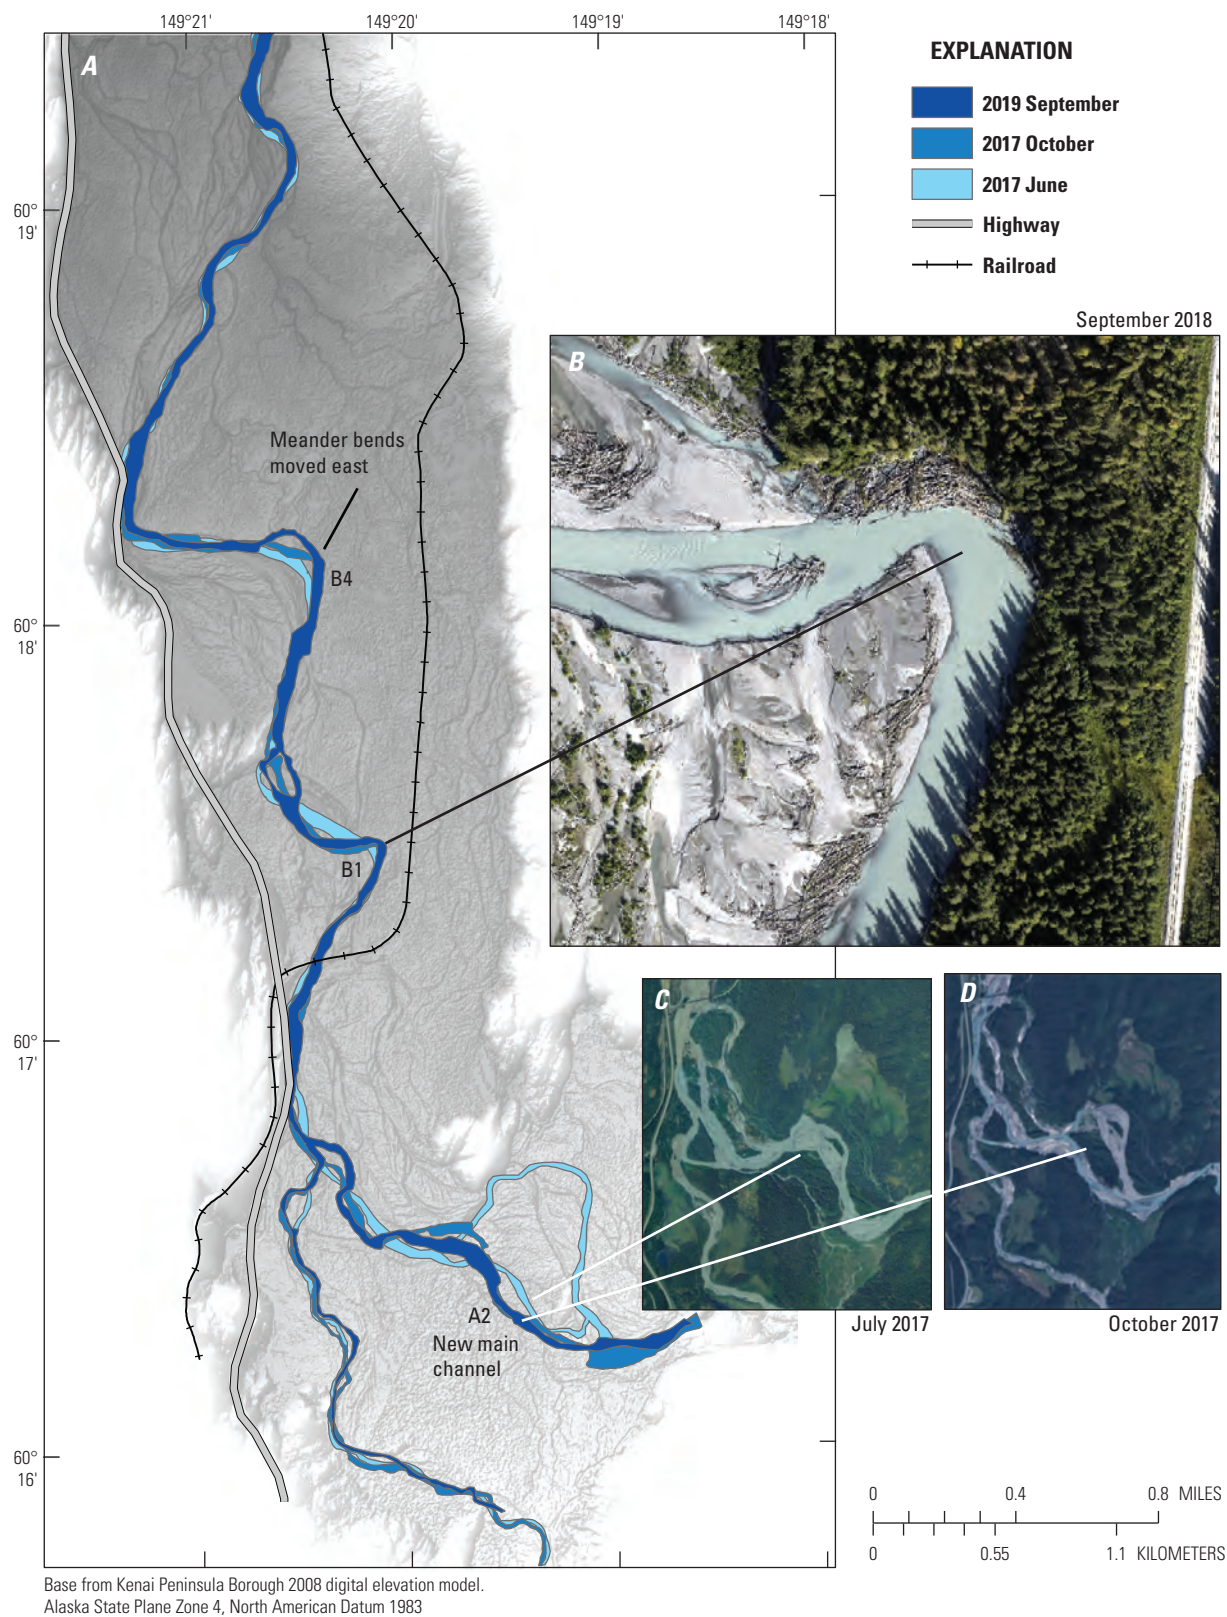
Figure 13. (A) Channel thalwegs from June 2017, October 2017, and September 2019 overlaid on a digital elevation model to show areas where the stream channel changed during 2017 and 2019 floods, near Seward, Alaska. (B) Aerial photo of meander bend B1 with freshly eroded debris (Kinzel and Legleiter, 2021). (C) Satellite imagery of A2 prior to avulsion (Copernicus Sentinel data 2017, processed by the European Space Agency). (D) Satellite image after avulsion at A2 (Copernicus Sentinel data 2017, processed by ESA).

Satellite images bracketing the 2017 and 2019 floods show changes that can clearly be attributed to each flood. Earlier imagery is not timed adequately to determine whether previous outburst floods were also responsible for channel change. During the 2017 flood, the main channel moved to an entirely new location at A2, abandoning a meander and eroding through 26 acres of densely forested floodplain. The meanders and B1 and B4 also eroded 100 and 200 ft eastward toward the railroad tracks, respectively (fig. 13). Although the avulsion at A2 in figure 13 did not directly threaten any infrastructure, it introduced thousands of trees to the river. Despite the higher peak flow, the 2019 flood did not appear to cause as widespread lateral channel change. The largest change was the eastward migration of the meander bend at B4 of nearly 300 ft. The meander bend at B1 did not appear to erode during the flood, and this may be because the bank was protected by a large logjam, introduced by the 2017 flood, that extended the length of the outer bend (fig. 13).

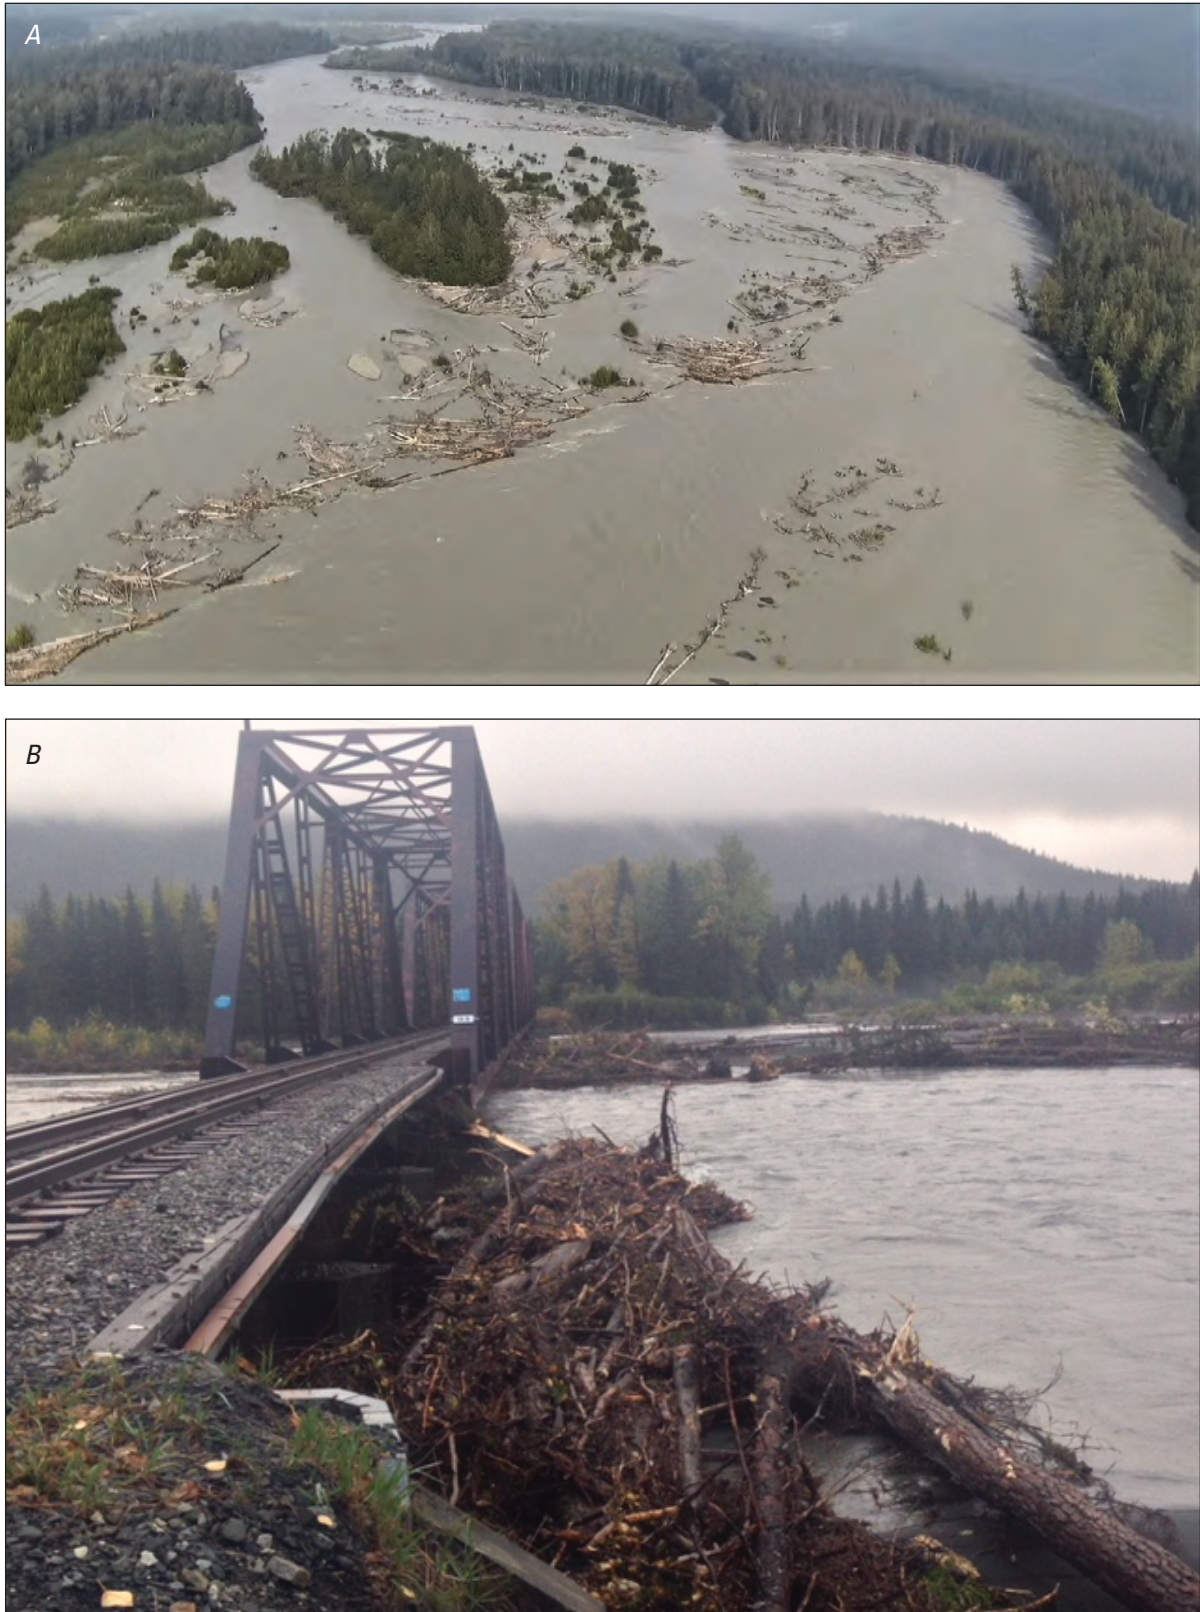
Figure 14. Debris at (A) meander bend at B1 during 2019 outburst flood and surrounding inundated gravel bars with debris from 2017 on them (Alaska Railroad photo, August 23, 2019) and (B) debris caught on the railroad Bridge 14.5 after the 2017 flood (Alaska Railroad photo, October 4, 2017), near Seward, Alaska.

(fig. 21). Model simulations show higher water surfaces at the left side of the bridge compared to observations. The blocking of piers with woody debris (fig. 14), not simulated in the model, may locally raise water levels at the bridge. Sediment transport simulations show flow skewed to the bridge opening and scour predominantly on the left bank side of piers. This is consistent with the flow pattern observed during floods. The lowest measured point on the cross-section in 2018 is 477 ft, while the lowest modeled point on the cross-section during the peak of the 2019 flood is 473.4 ft, just below the top of footing elevation of 474 ft. As described above, an increasing percentage of flow bypasses the railroad bridge to the east and flows behind the railroad tracks. If bypass flow is redirected through the bridge with engineering structures or as a result of channel change, both scour and water-surface elevation would increase.
